Navigation System Firmware Improvement (Generation 6)

Service Category Audio/Visual/Telematics

Section Navigation/Multi Info Display

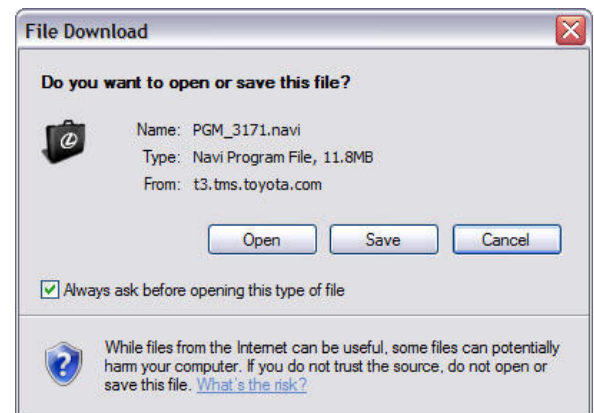
Figure 1.

The file is large and may take up to 10 minutes to download.

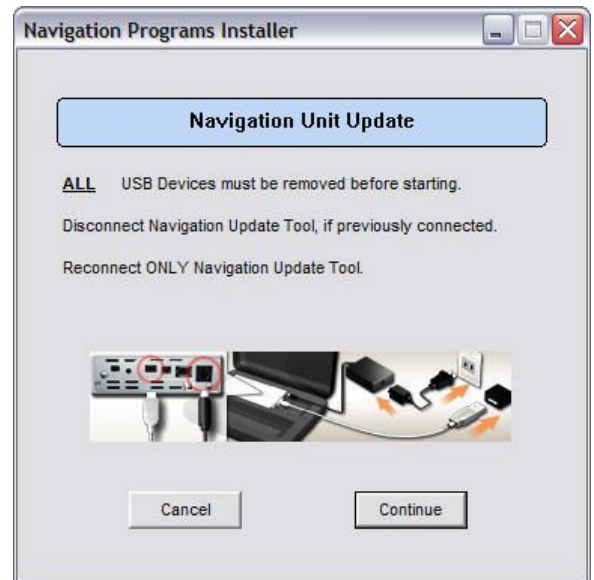
Figure 2.

6. Connect the Navigation Update Tool to the PC using the USB cable.
 - A. Make sure the USB cable is secured in **both** the PC and Navigation Update Tool USB ports.
 - B. Confirm that the Navigation Update Tool is powered correctly.
 - C. Turn the power ON.
 - D. Click *Continue*.
7. Verify that both the transfer mode display light (green) and power supply display light (blue) are lit, then click *Continue*.

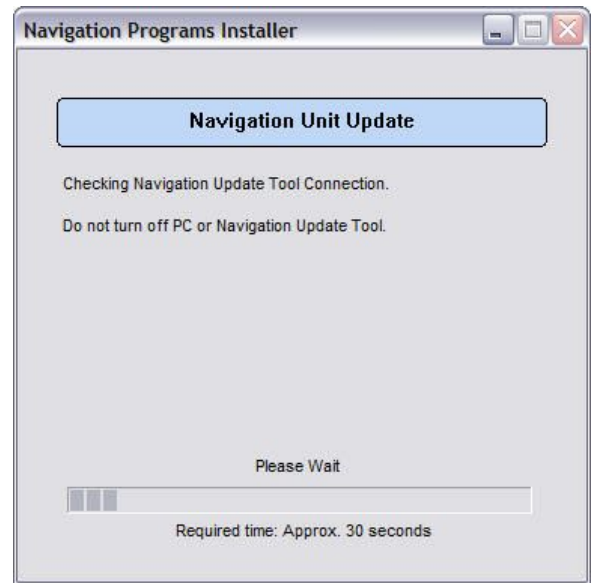
Figure 3.

8. The software will perform a connection check with the Navigation Update Tool. In the event an error is shown, please recheck the USB connection.

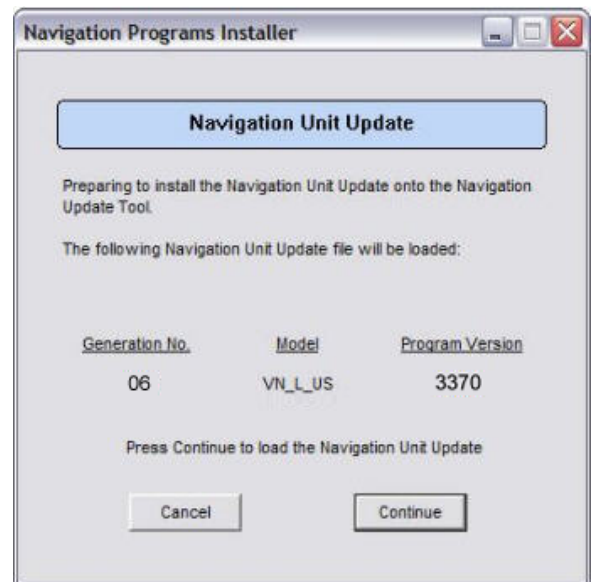
Figure 4.

9. Navigation Firmware is ready to be loaded onto the Navigation Update Tool, click *Continue*.

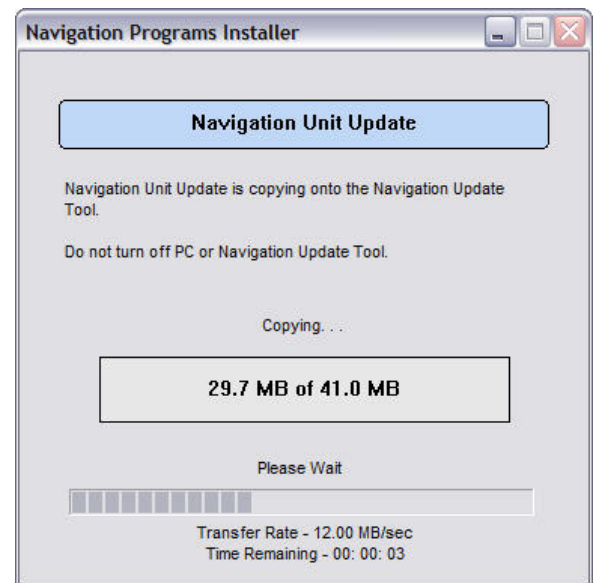
Figure 5.

10. Navigation Firmware will now load onto the Navigation Update Tool.

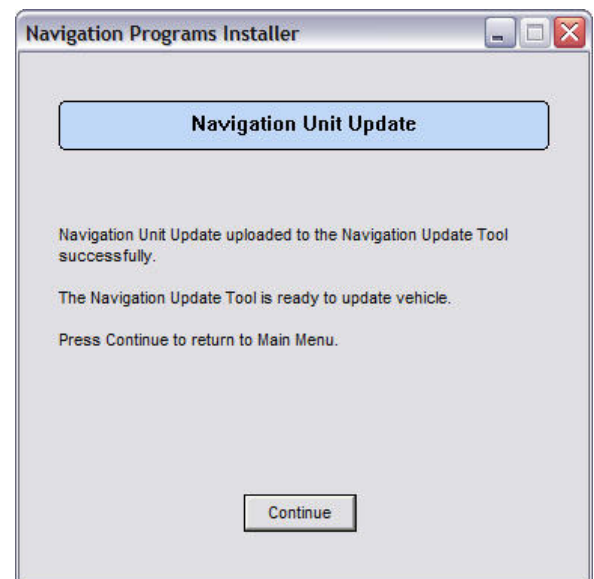
Figure 6.

11. Once the Navigation Firmware is successfully loaded onto the Navigation Update Tool, click *Continue* to finish the installer.

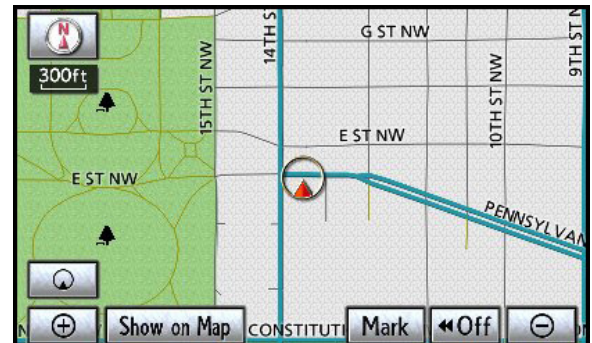
Figure 8.

4. Select *Show on Map*.

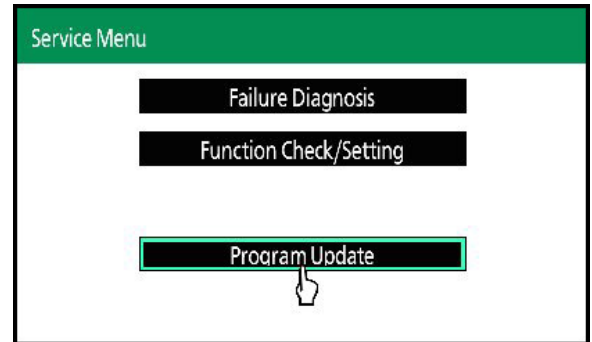
Figure 9.

6. Select *Program Update* from the Service Menu.

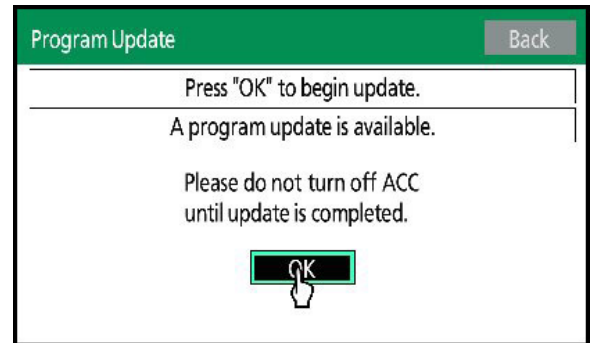
Figure 10.

7. Select *OK*.

Load time for the program update is between 5 and 15 minutes.

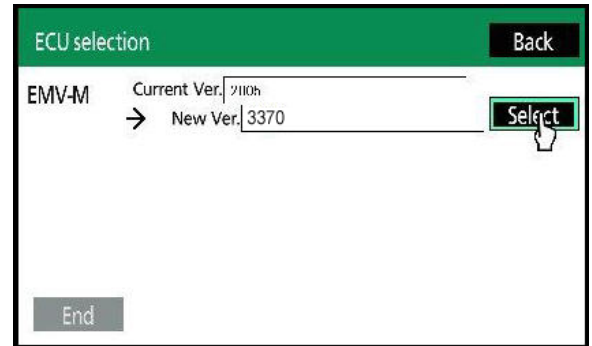
Figure 12.

- When the *ECU Selection* screen appears, confirm the Current version is less than the New version. If yes, then press *Select*. If no, then select *End* and go to step 11.

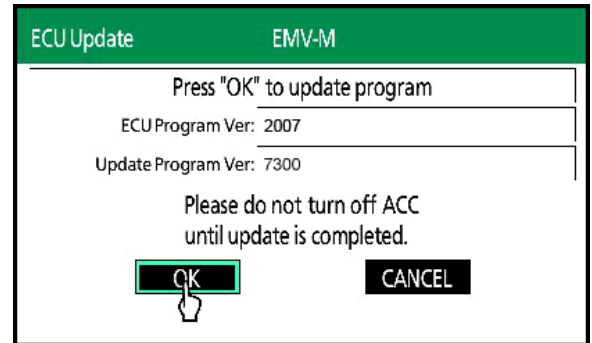
Figure 13.

- When *EMV-M* screen is shown select *OK*.

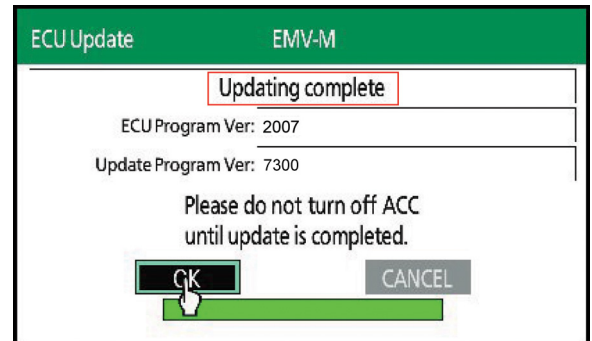
Figure 14.

- After about 1 minute, if the update was successful the display will indicate "*Updating complete*" at the top of the screen. Select *OK* to continue.
