Lexus : IS F : 2008-10
Current Measurements

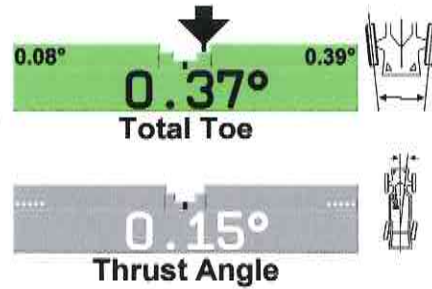
- Excessive Toe could cause scuffing or shoulder wear.

Actual	Before	Specified Range
-1.4 [°]		-1.5° 0.0°
0.16 [°]		0.04° 0.20°

Actual	Before	Specified Range
-1.2 [°]		-1.5° 0.0°
0.11 [°]		0.04° 0.20°
