Techstream ECU Flash Reprogramming Procedure

Service Category Engine/Hybrid System

Section Emission Control

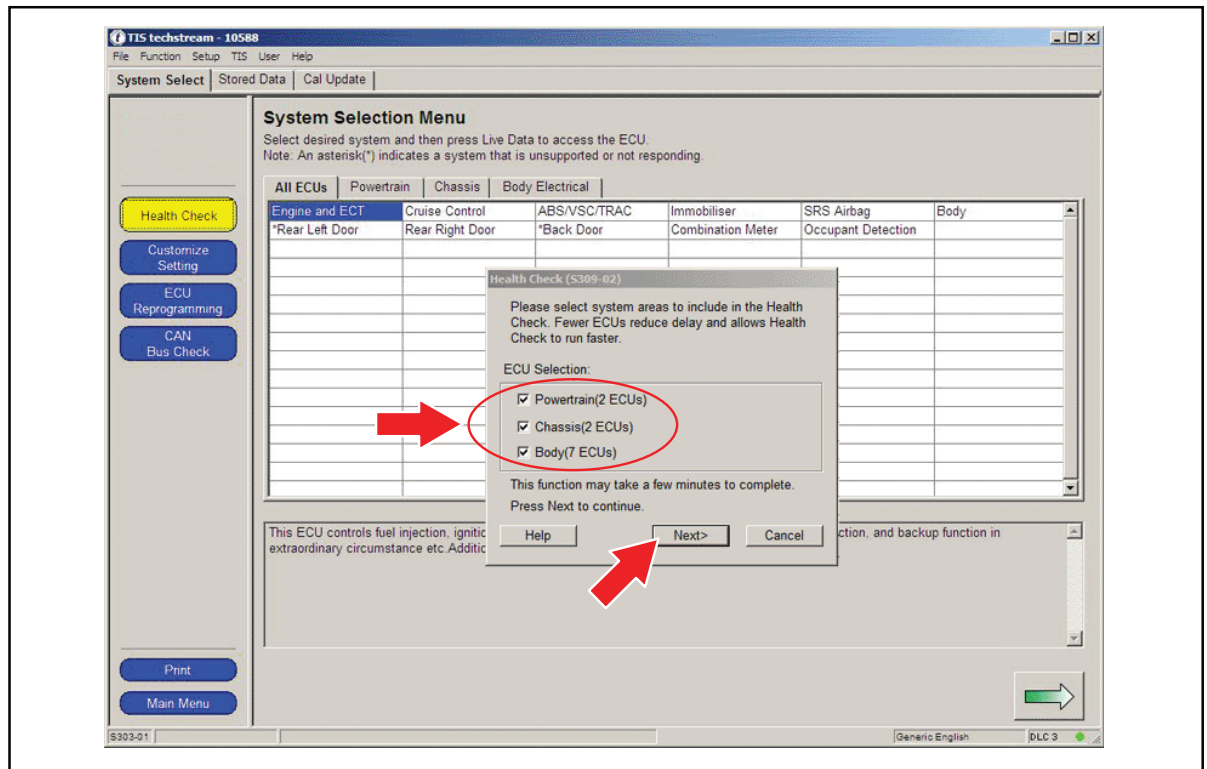
Figure 3.

C. Choose desired ECU group(s) in the *Health Check* dialog box.

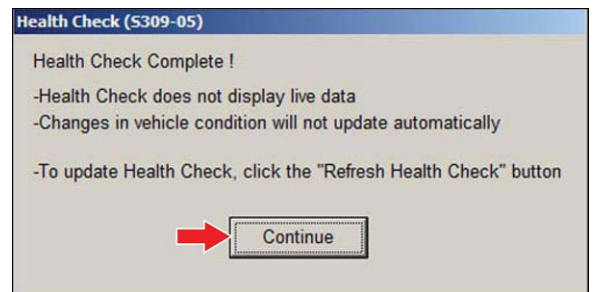
Figure 4.

E. Click *Continue* to view Health Check results.

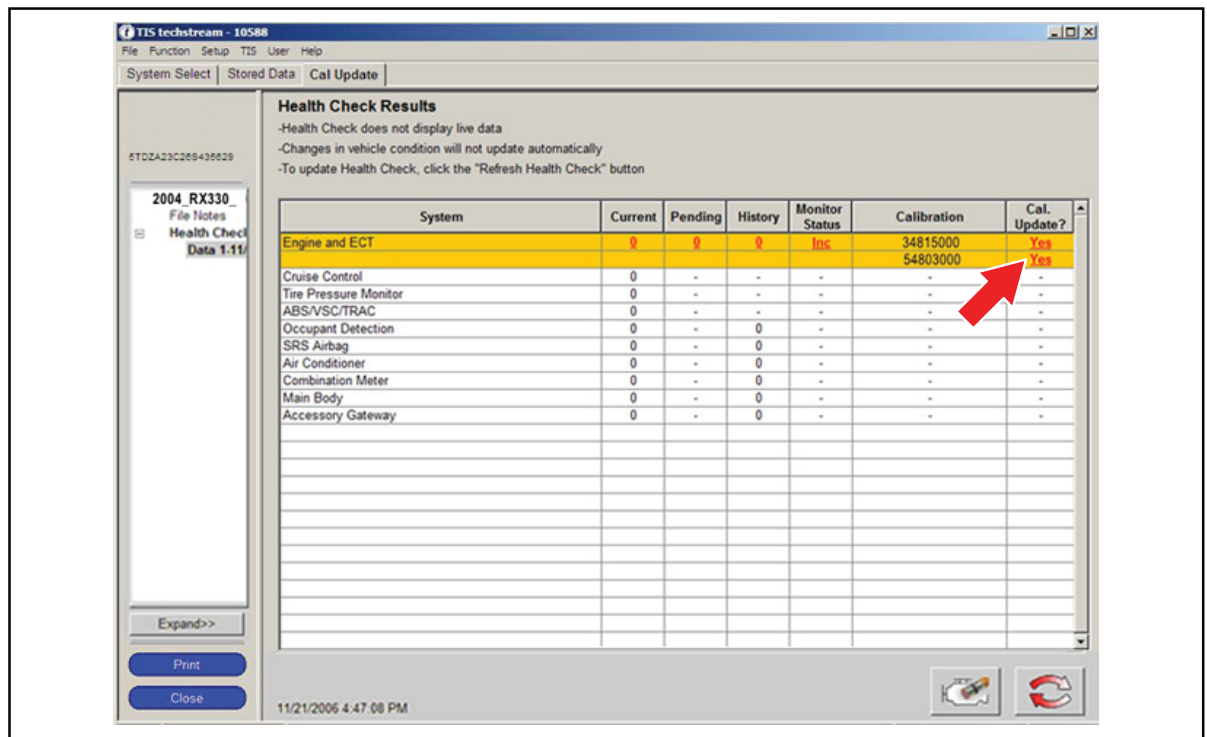
Figure 5.

F. Available calibration updates are indicated by a **Yes** link in the *Cal. Update?* column. Click the **Yes** link to access the appropriate Service Bulletin on TIS.

- Note any DTCs stored in systems that will be flash reprogrammed.
- Clicking the **Yes** link will automatically launch TIS and perform a calibration search.

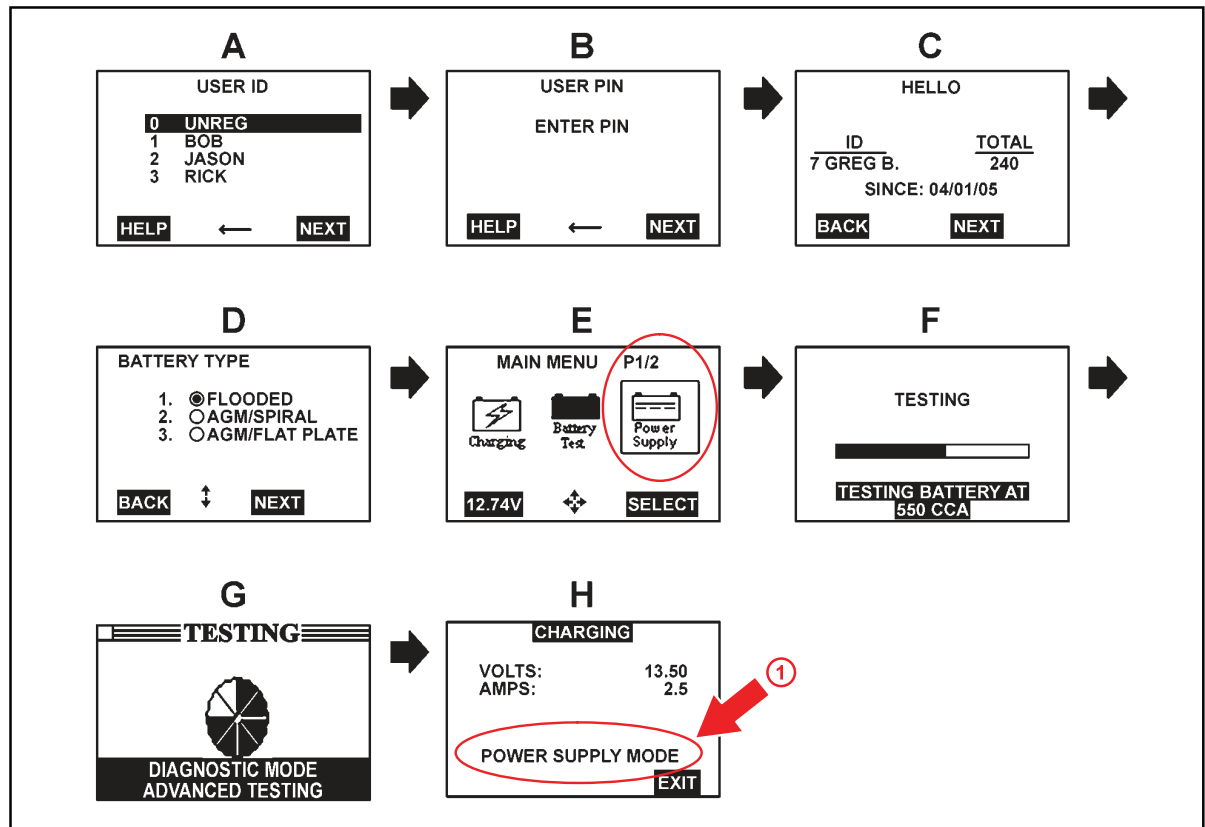
Figure 7.

2. Connect the GR8 Battery Diagnostic Station.
 - A. Connect the GR8 Battery Diagnostic Station to the vehicle and turn it ON.
 - B. Select Power Supply Mode by following the screen flow below.

- ECU damage may occur if the correct battery charger and mode setting are NOT used.
- Power Supply Mode is used to maintain battery voltage at 13.5 volts while flash reprogramming the vehicle.
- For details on how to use the GR8 Battery Diagnostic Station, refer to the [GR8 Instruction Manual](#) located on TIS, *Diagnostics – Tools & Equipment – Battery Diagnostics*.

1 Confirm Power Supply Mode Is Selected

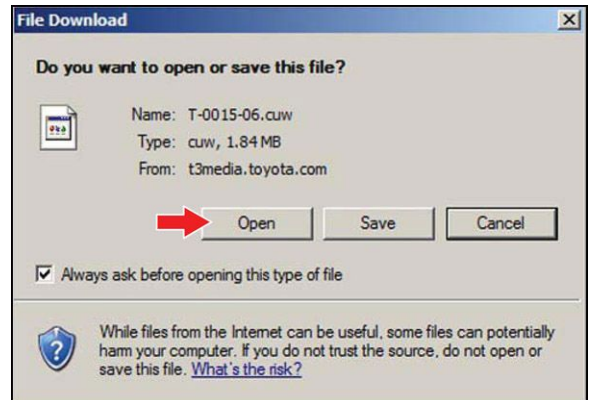
Figure 9.

- B. Click *Open* to load calibration file information.

Techstream pulls calibration files as needed to ensure the latest calibration file is used. Do NOT save calibrations locally on the hard drive or other media.

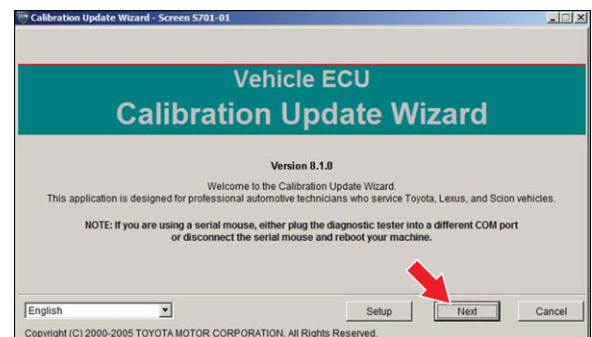
Figure 10.

- C. Click *Next* to start the calibration update process.

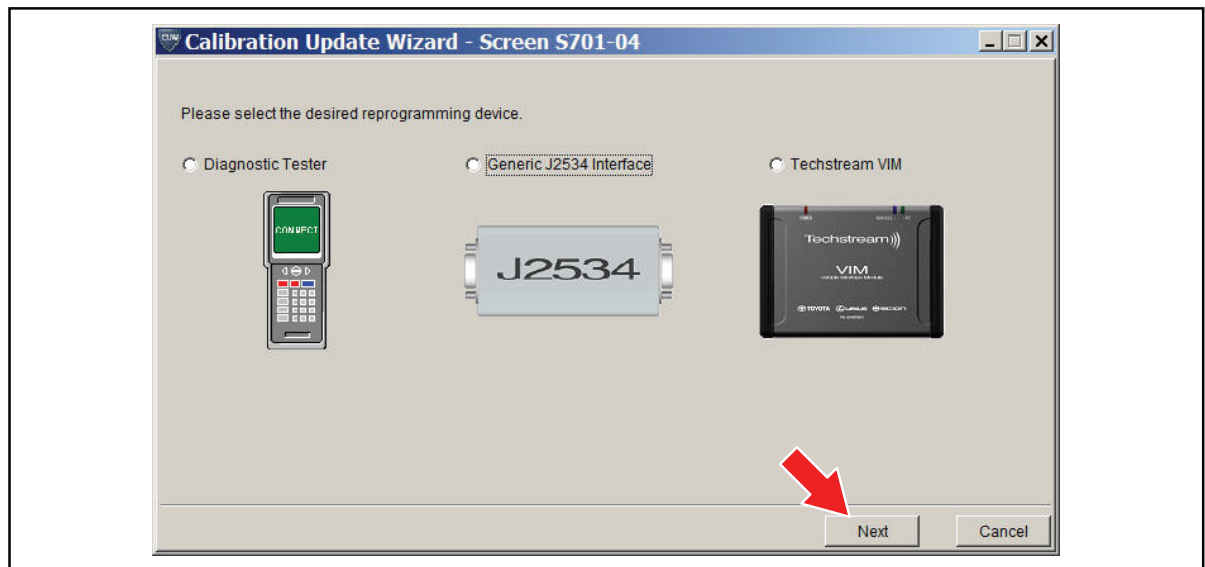
Figure 11.

D. Select the correct reprogramming device.

- If using Techstream 2.0, select *Generic J2534 Interface*.
- If using Techstream Lite, select *Generic J2534 Interface*.
- If using Techstream, select *Techstream VIM*.

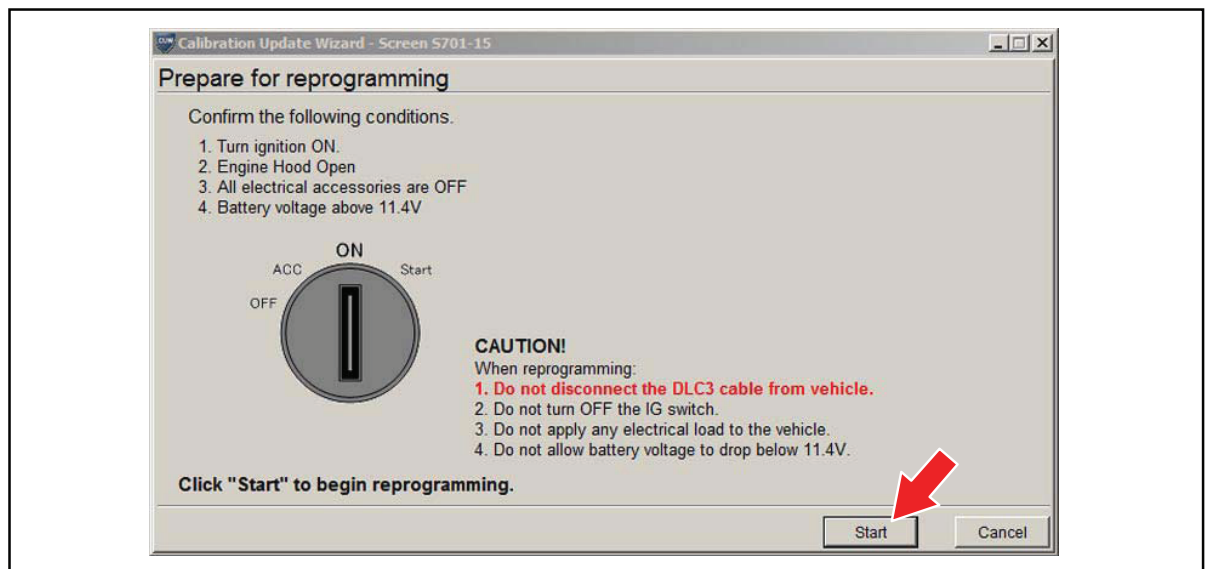
Figure 16.

- Ignition is ON and engine is OFF or “READY” OFF (hybrid vehicles).
- Hood is open.
- All accessories are OFF.
- Battery voltage is above 11.4 volts.

Verify the vehicle is connected to a battery charger before continuing — If battery voltage falls below 11.4 volts, ECU damage may occur.

Then click *Start*.

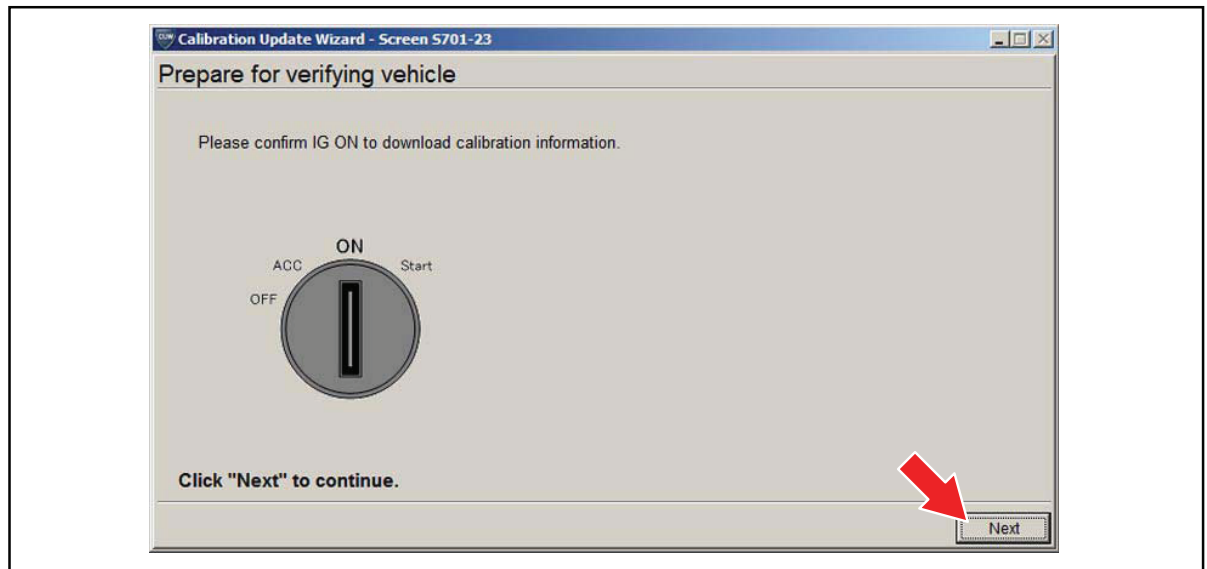
Figure 22.

N. Turn ignition to the ON position. Then click *Next*.

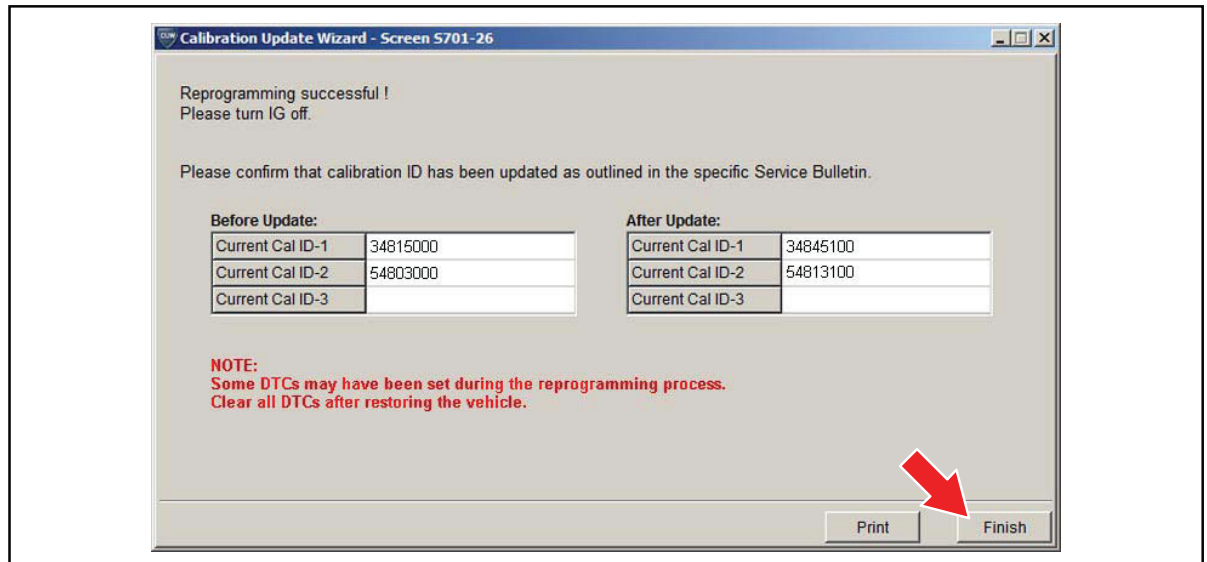
Figure 23.

O. Confirm all calibrations were updated as specified in the Service Bulletin. Then click *Finish*.

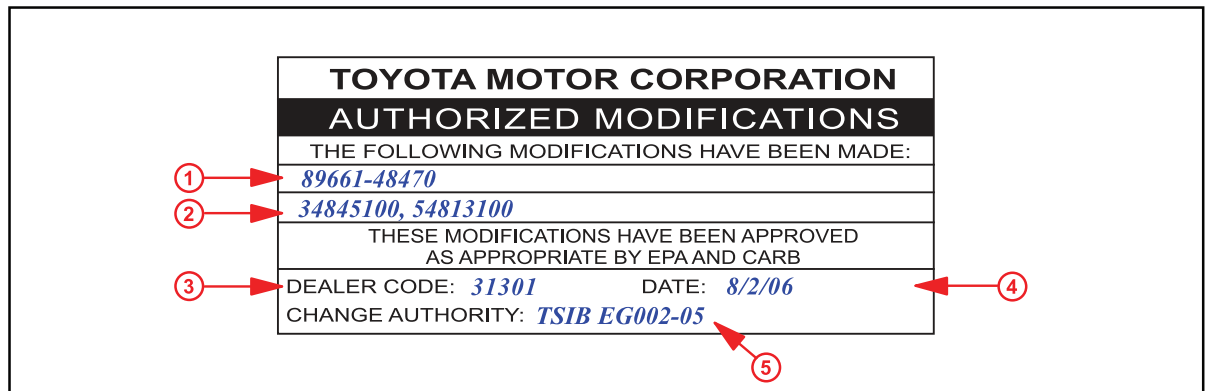
Figure 24.

- A. Using a permanent marker or ball point pen, complete the Authorized Modifications Label and attach to the vehicle. The Authorized Modifications Label is available through the MDC, P/N 00451-00001-LBL.

1	Replacement ECU Part Number
2	Calibration ID(s)
3	Dealer Code

4	Date Completed
5	Service Bulletin or Campaign Number
