L-TCI-5285

Vehicle Bucking on 1 - 2 and/or 2 - 3 Upshifts and Surge Between 0 - 75 km/h

Service

Section Engine Control

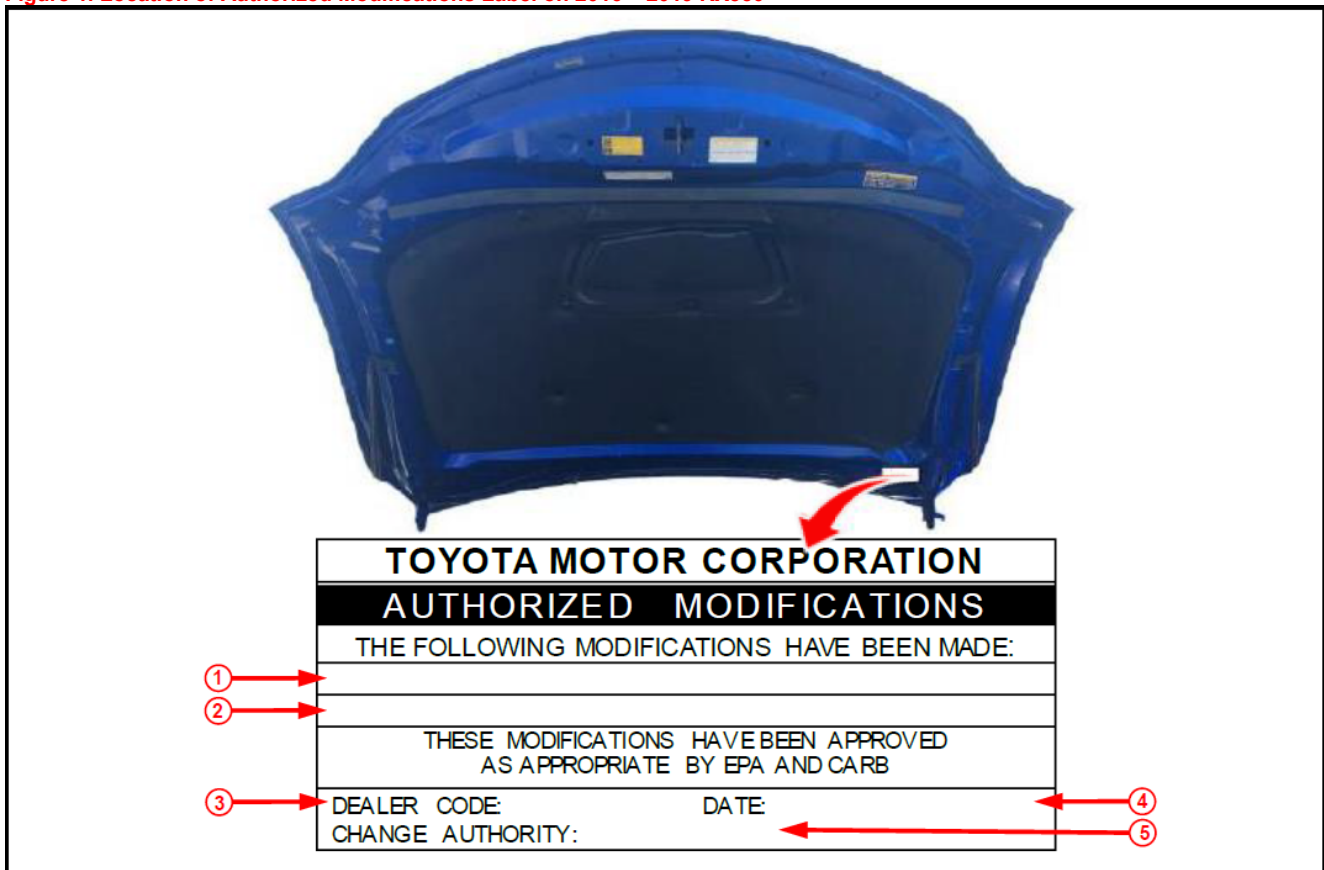
Figure 1. Location of Authorized Modifications Label on 2016 – 2019 RX350

1	Replacement ECM (PCM) Part Number (e.g., 89661-0E765)
2	New Calibration ID(s) (e.g., 896630E36600)

3	Dealer Code
4	Date Completed
5	This TSB Number

4. Install the Authorized Modifications Label.
 - A. Using a permanent marker, enter the following information on the label:
 - ECM part number [Refer to the Parts Information section for the NEW PART NUMBER]
 - Calibration ID(s) [Refer to the Calibration Information section for the NEW CALIBRATION ID]
 - Dealer Code
 - Repair Date
 - Change Authority [This bulletin number]
 - B. Affix the Authorized Modifications Label to the vehicle at the location shown in Figure 1. The Authorized Modifications Label is available through your facing PDC, P/N 00451-00001-25.
5. Test-drive the vehicle to confirm proper operation.
