Date: January 9, 2015
Order No.: P-B-47.10/63
Group: 47

SUBJECT: Model 211, Model Years 2003- 2009 (AMG models not included at this time) and Model 219, Model Years 2006- 2011 (AMG models not included at this time) Fuel Odor In the Area of the Fuel Tank

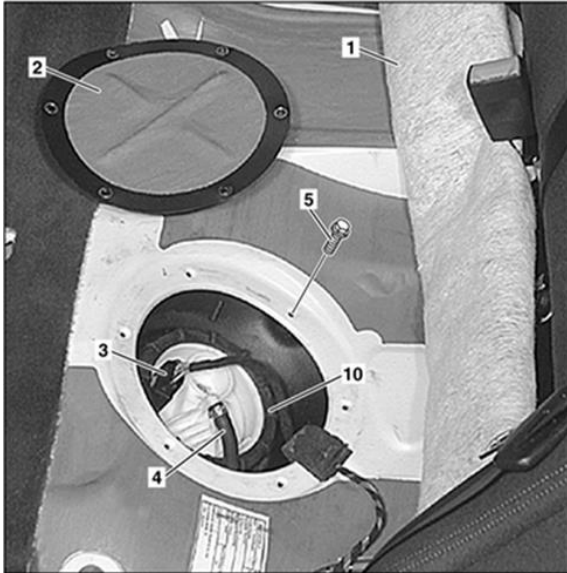
Figure 1

Remove screws (5, Figure 1) and take off both fuel tank access covers (2).

During assembly, do not install the covers (2) until after running engine and checking for fuel leaks.

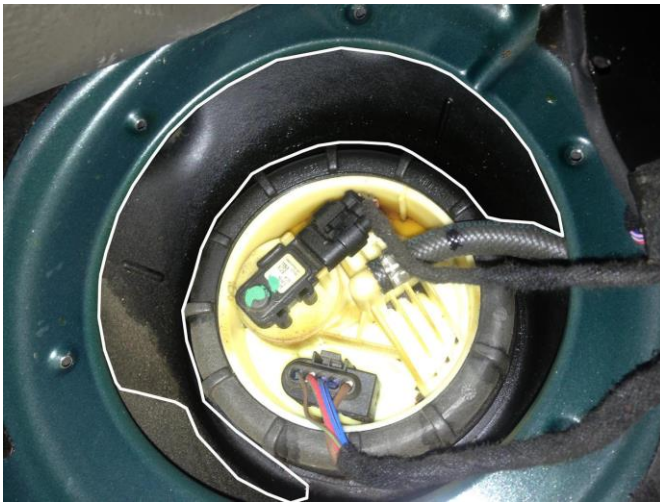
Figure 3 (Fuel residue outlined)

**Note:** Fuel residue (outlined, Figure 3) and/or liquid fuel must be visible in photo.

- Provide symptom string: Power Generation / Fuel systems / Fuel system odor / Odor
- Attach (detailed) photographs of the suspect area to the case. (see example, Figure 3).
