Last Modified: 7-25-2017	6.8:8.0.51	Doc ID: RM000002U67001X
Model Year Start: 2007	Model: LS460	Prod Date Range: [09/2006 -]
Title: AIR CONDITIONING: AIR CONDITIONING AMPLIFIER: REMOVAL; 2007 MY LS460 [09/2006 -]

REMOVAL

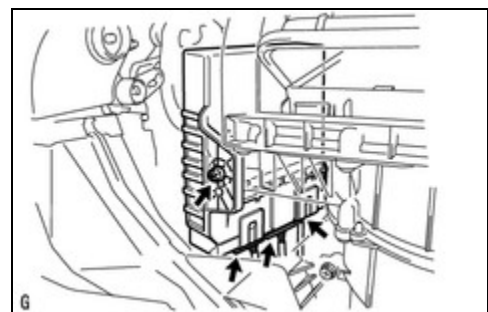
10. REMOVE AIR CONDITIONING AMPLIFIER ASSEMBLY

- (a) Disconnect the 3 connectors.
- (b) Remove the screw and amplifier.
