Subject: **Navigation Micro SD Card Error** Market: **USA**
 Service Category: **Audio/Visual/Telematics** Section: **Navigation/Multi Info Display**
 Applicability: **Generation 8 Navigation**

Navigation Micro SD Card Error

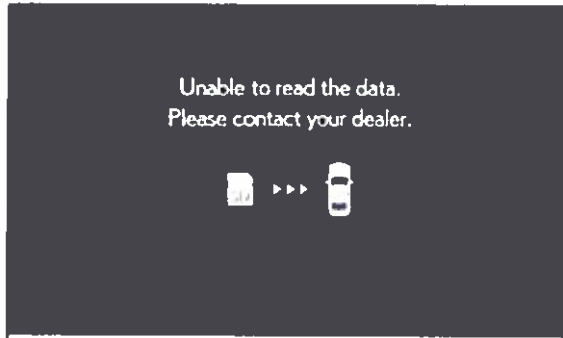
Navigation microSD card reads an error when missing or swapped from another vehicle.

Error message when micro SD card is swapped from another vehicle.

- Do not interchange mSD cards. Each mSD card is "paired" with head unit.
- Once an mSD card is paired with a vehicle, it may not be swapped into a different vehicle.
- A new mSD card is "unpaired" and becomes "paired" when inserted into a vehicle.
- Service exchange radios come in "unpaired" service mode and accept used mSD cards.

- If an mSD card is swapped, returning it to the original vehicle will remedy the problem.

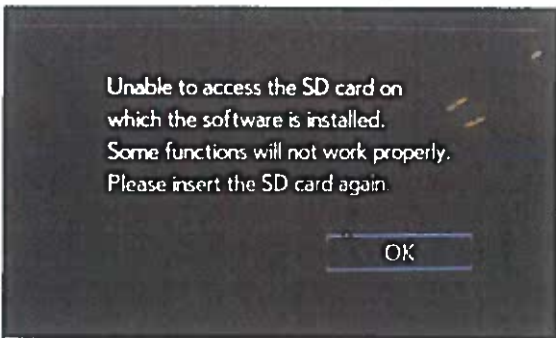
Error message when micro SD card is missing.

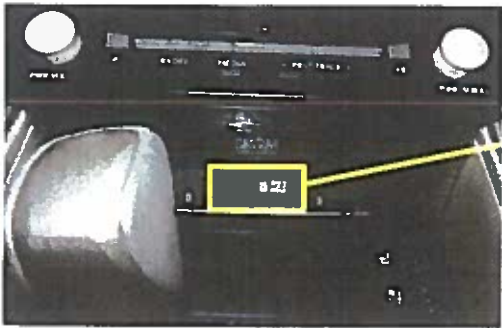
IS250/350 Micro SD card installation location.
