## REPLACEMENT

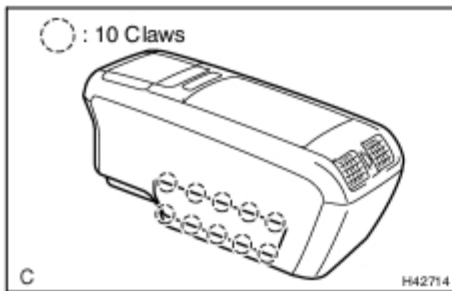
### 17. REMOVE CONSOLE BOX HOLE COVER NO.2

- (a) Using a screwdriver, remove the console box hole cover No.2.

#### HINT:

Tape up the screwdriver tip before use.

### 18. REMOVE CONSOLE BOX HOLE COVER

- (a) Using a screwdriver, remove the console box hole cover.

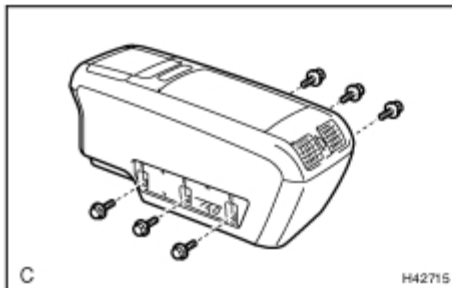
### 19. REMOVE CONSOLE BOX ASSY

- (a) Remove the 6 bolts.
- (b) Disconnect the console box slide cable.
- (c) Remove the clamp and disconnect the connector, and then remove the console box assy.
